U.S. Battery's Brand New RE-LI6XC

SPECIFICATIONS RE L16 / 6-VOLT

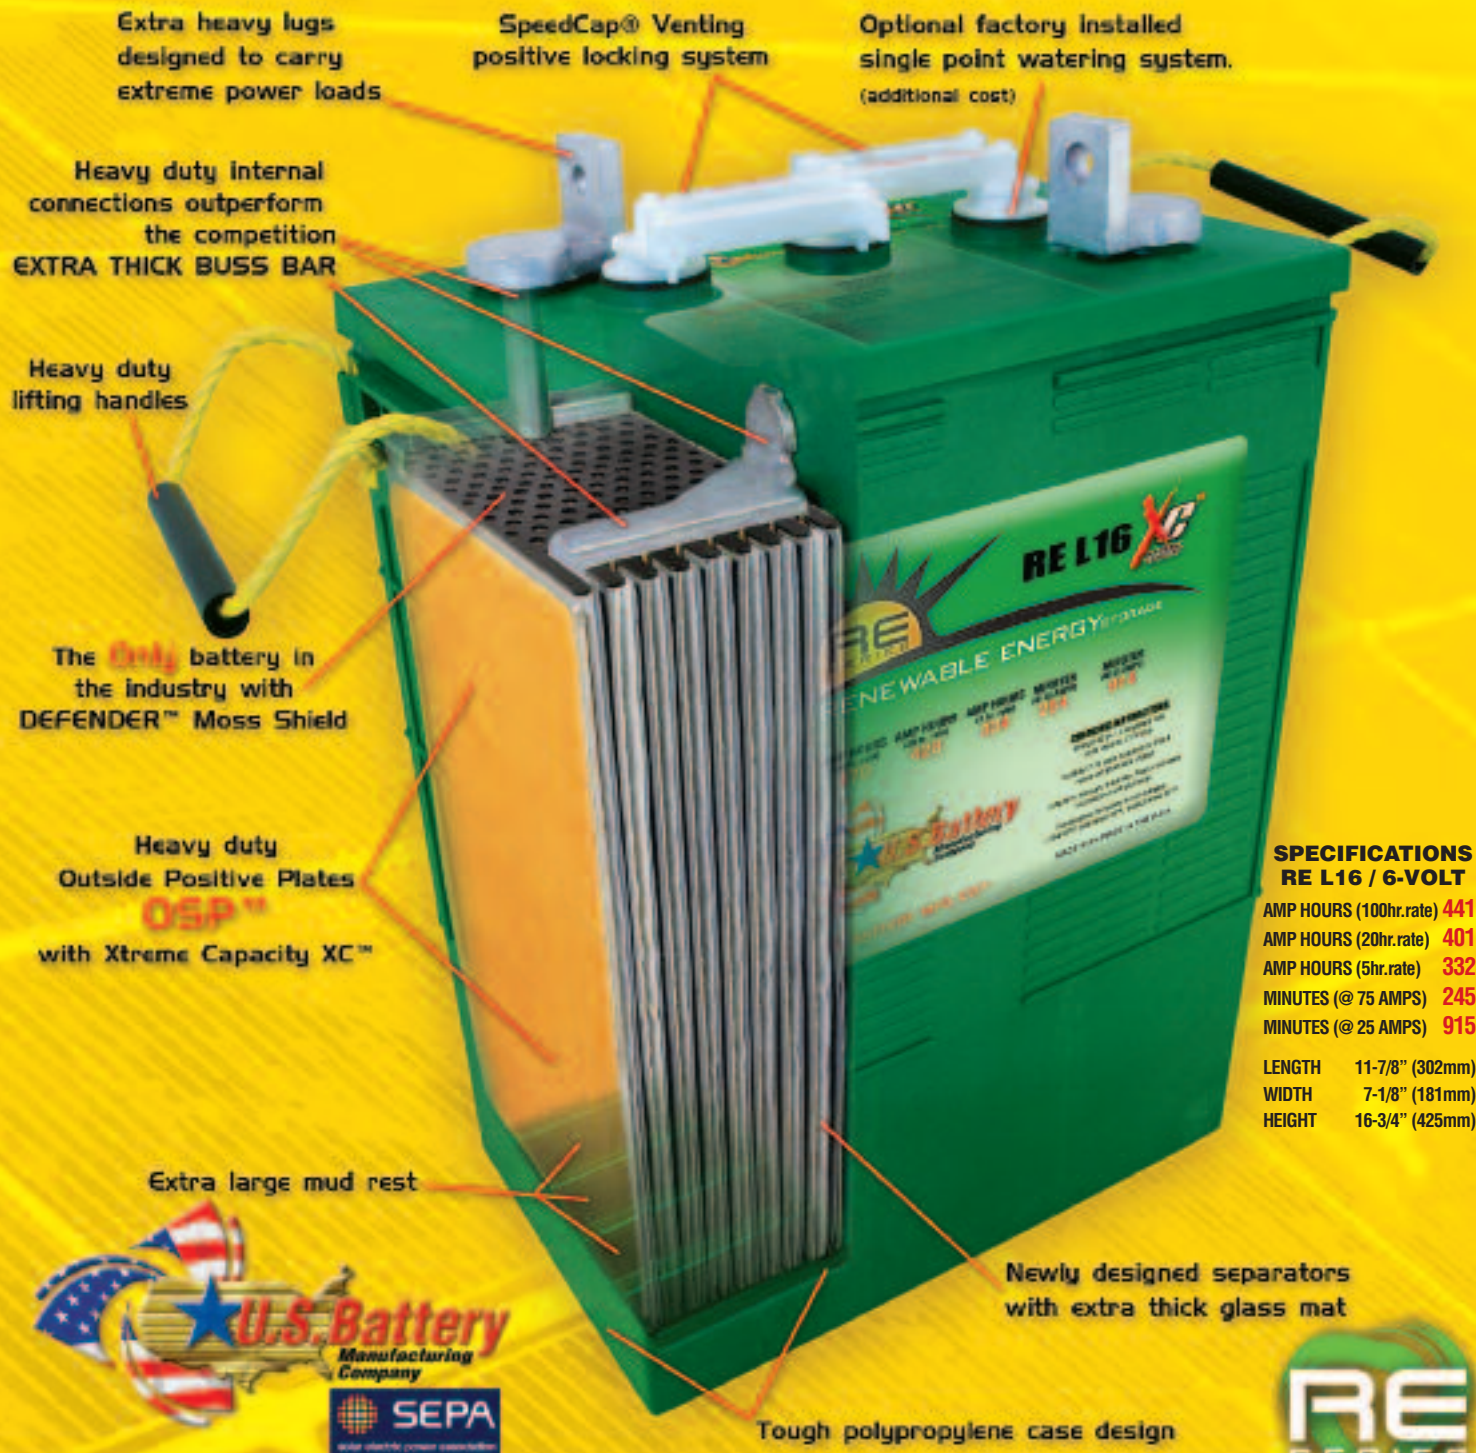
Outside Positive Plates (OSP™) = More Amp Hours.

The primary causes of positive plate deterioration are positive grid corrosion and positive active material wear-out or softening and shedding. These failure modes are the result of the normal overcharge required to fully charge batteries and to mix the electrolyte to prevent electrolyte stratification. In addition, batteries that are used in applications that require continuous float charging may be more susceptible to grid corrosion as a result of prolonged overcharging. Also, batteries that are subjected to frequent deep discharges (greater than 50% DOD) often exhibit increased effects from positive active material wear-out. This is usually the case in Renewable Energy applications. Testing at U.S. Battery has shown that an effective method for mitigating the effects of positive plate deterioration is to increase the ratio of positive to negative active material by **adding a positive plate** and removing a negative plate from a conventional cell design resulting in an Outside Positive (OSP™) cell design vs a conventional Outside Negative (OSN) cell design. This design approach results in a cell with increased positive to negative active material ratio, increased positive to negative grid ratio, and increased protection of the positive plate from positive plate deterioration. This results in longer life, increased capacity, and more stable performance over the life of the battery.

The only battery in its class with DEFENDER™ Moss Shields for longer reliable battery life.

Electrical shorting can be caused by 'mossing' shorts at the top of the cell element. These mossing shorts are the result of positive active material particles that have softened and shed from the positive plates, become suspended in the electrolyte, and eventually collect at the top of the cell element. Once enough of this material has collected to bridge the tops of the separators, it can contact both a positive and a negative plate where it converts to conductive lead and forms a short circuit resulting in cell and battery failure. This failure mode is more prevalent in stationary applications than in vehicular applications because of the absence of vibration and shock that normally dislodges the mossing material and causes it to fall to the bottom of the container where it collects innocuously in the mud cells. Testing at US Battery has shown that the use of insulating 'moss shields' in batteries used in these stationary applications can effectively prevent the formation of these mossing shorts. This results in longer life, increased capacity, and more stable performance over the life of the battery.
